**FEDERAL AVIATION ADMINISTRATION
AIRWORTHINESS DIRECTIVES
SMALL AIRCRAFT, ROTORCRAFT, GLIDERS,
BALLOONS, & AIRSHIPS**

BIWEEKLY 2005-22

BW 2005-22

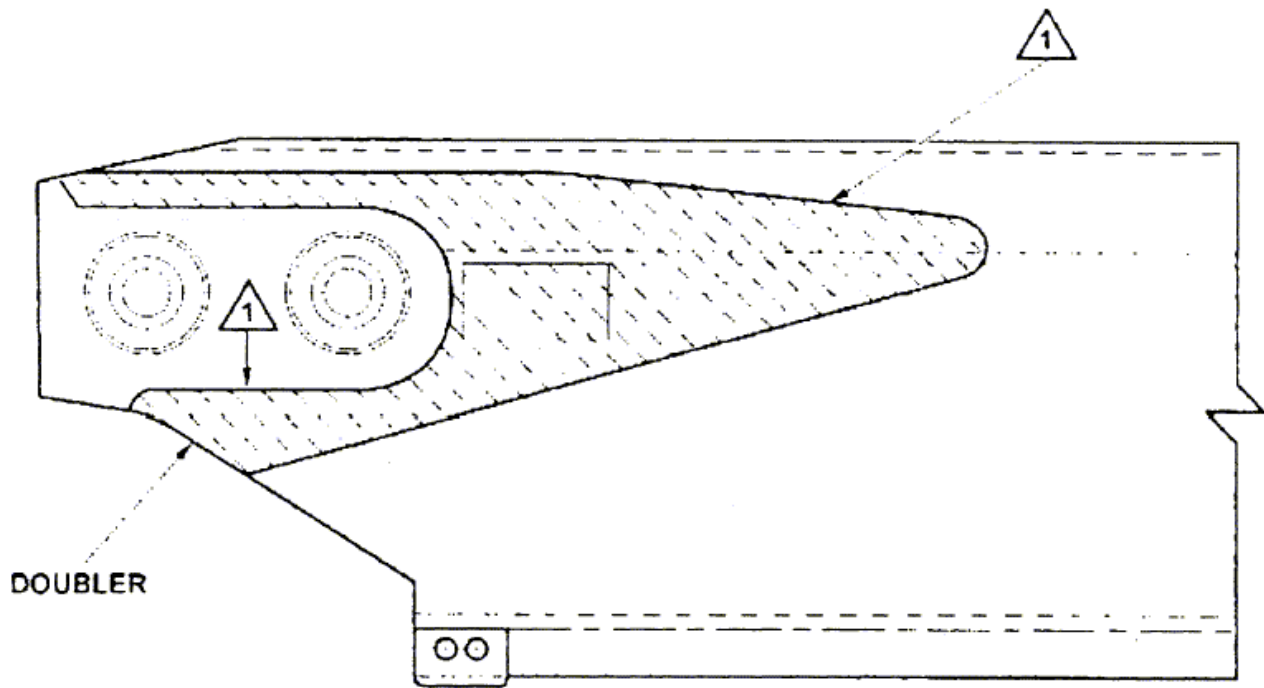
(a) Before the first flight of each day, clean each blade and visually check the blade root doublers for an edge void or de-bond on both sides of each blade as depicted in Figure 1 of this AD. An owner/operator (pilot), holding at least a private pilot certificate, may perform this visual check and must enter compliance with this paragraph into the helicopter maintenance records by following 14 CFR sections 43.11 and 91.417(a)(2)(v).

1 Inspect the doubler for an edge void or de-bond on both sides of each blade.

(b) If an edge void or a de-bond is found, before further flight, replace the blade with an airworthy blade with a serial number other than those to which this AD applies.
